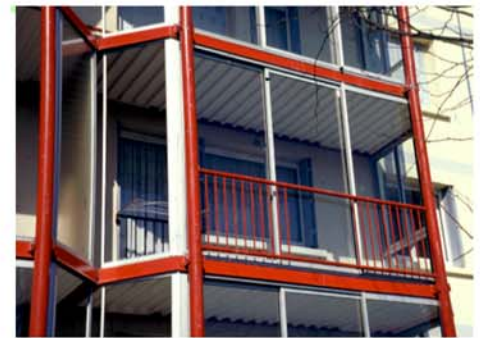
Glazed sunspaces and transparent insulation

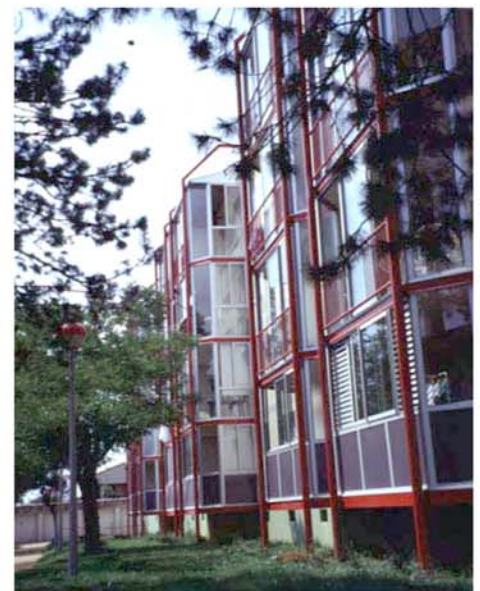
Greenhouse detail
